## Collapse of Underground Storm Water Detention System

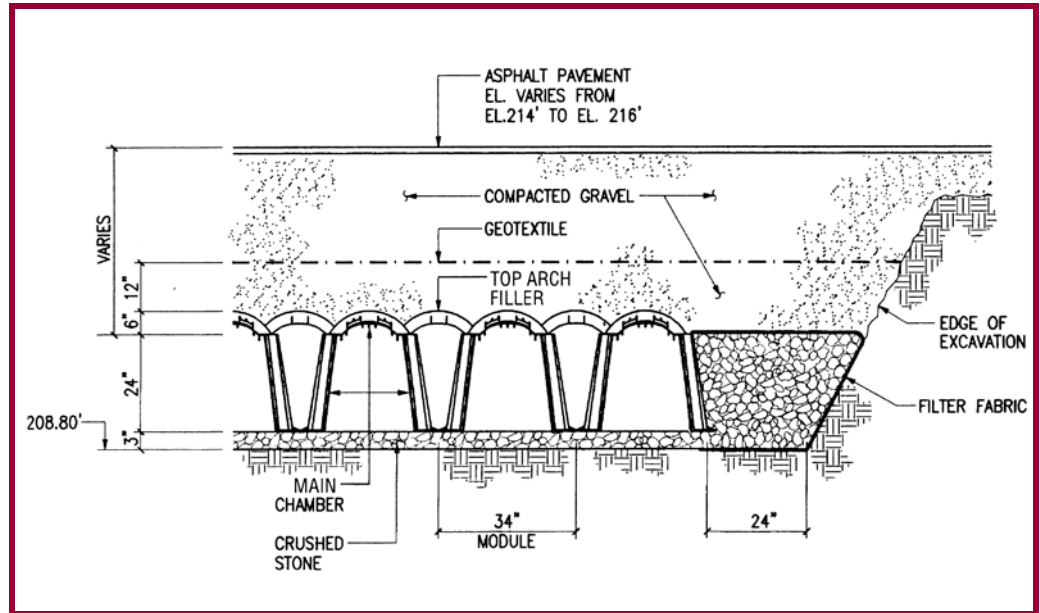
Figure 3. Section through storm water detention system showing design requirements.

The stress in the main chamber legs due to the weight of the long term superimposed load (i.e. the paving and compacted gravel), as shown on Figure 3, varied from 270 psi to 420 psi. As shown on Figure 10, the effective Modulus of Elasticity for an axial loaded member with a sustained stress midway between 200 and 500 psi at one hour is 80,000 psi, but after 1000 hours (42 days) the effective Modulus of Elasticity will drop to 38,000 psi, and after 100,000 hours (11 years) it will drop to 24,000 psi. These values may be low for the subject HDPE, but the trends will be similar for a higher strength HDPE; i.e. the original Modulus of Elasticity will be reduced to approximately 50% after 1000 hours and 30% after 100,000 hours.

The manufacturer of the HDPE components specified criteria for the design of the storm water detention system, the details of which are shown on Figure 3. The manufacturer specified that the depth of the compacted gravel backfill above the top of the main chamber units be a minimum of 18 inches and a maximum of 48 inches. The actual depth of the compacted gravel backfill of the subject storm water detention system varied between

38 and 48 inches. The estimated modulus of elasticity at 1 hour of sustained load is 110,000 (AASHTO, 1991).<sup>4</sup> Calculations based on this modulus indicate that the legs of the main chamber unit would not buckle. When the legs of the main chamber units collapsed, the compacted gravel backfill had been in place approximately 1½ months or 1100 hours. As the trends of Figure 10 show, the effective modulus of elasticity would be reduced by approximately 50% in that time, and calculations indicate that the legs of the main chamber unit would buckle under this reduced modulus.

The cause of the collapse was that the manufacturer did not understand the creep characteristic of the viscoelastic HDPE material used

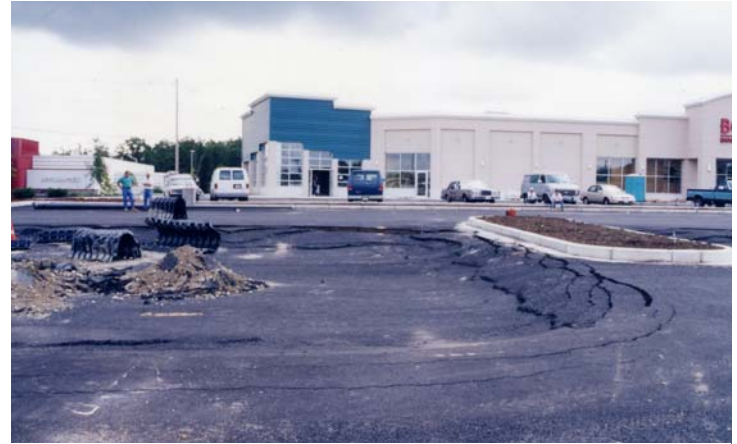
The subject storm water detention system was constructed in the middle of July 1997 and collapsed on August 31, 1997. Figures 4 and 5 (*page 3*) show the collapse of the northerly field of the storm water detention system. The collapsed southerly field can be seen in the background of Figure 4.

**Figure 5. South side of northerly field, looking east.**

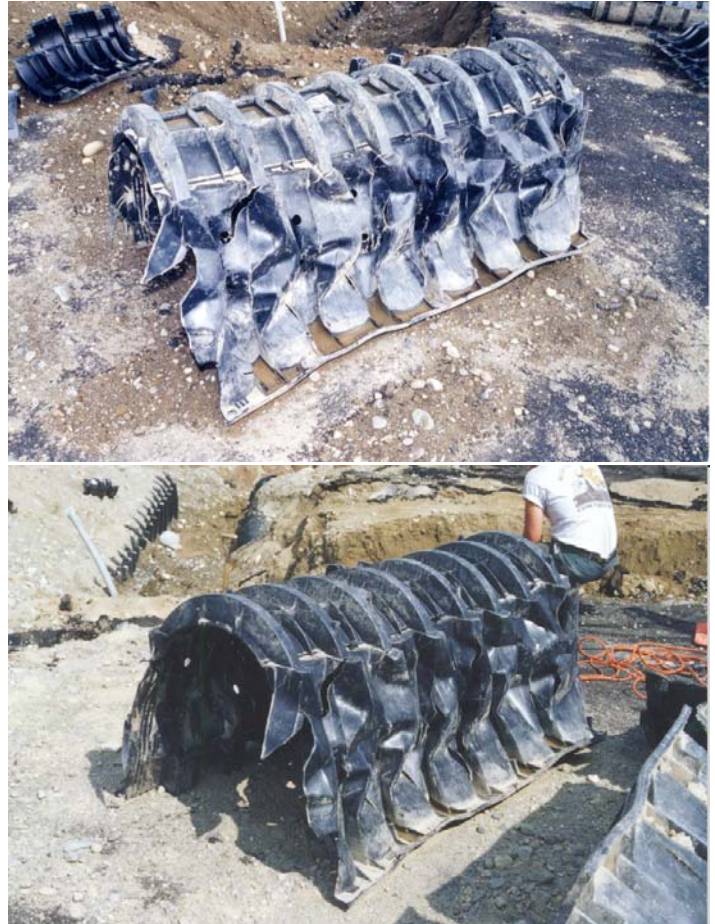
Figure 8 shows the rebound of the legs after they were removed from the collapse.

**Figure 8. Recovery of deformation with time. The middle photo of Figure 7 shows the buckled shape when the arched filler was cut out; The top photo in this figure shows partial recovery of the deformation of one of the legs of the main chambers within a 1/2 hour after being cut out. The bottom photo shows full recovery of most of the deformation days after it was originally excavated by the contractor.**
