## Collapse of Underground Storm Water Detention System

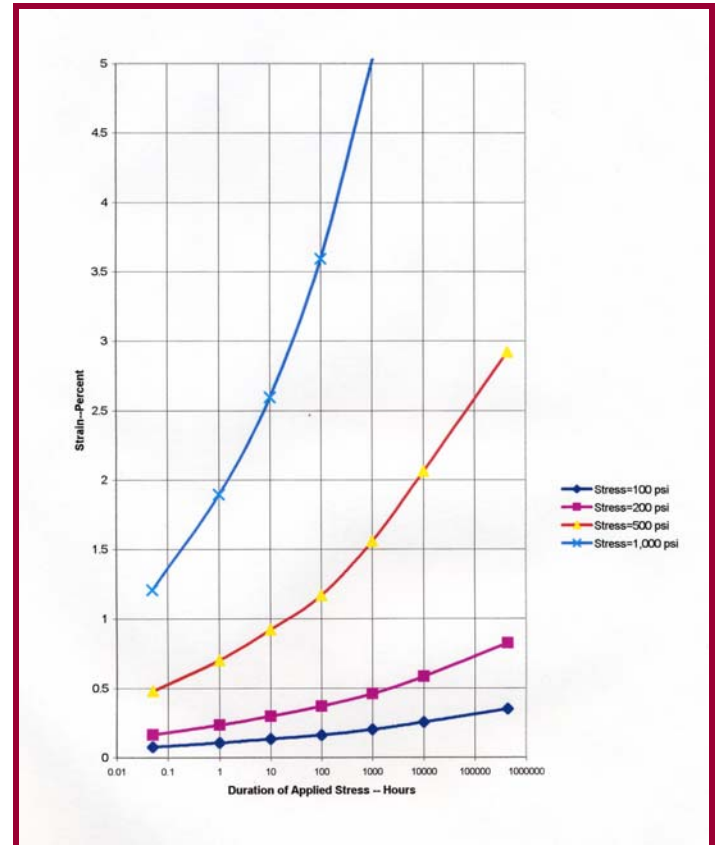
Plastics, in general, and HDPE in particular, are viscoelastic, which means that the material keeps deforming under sustained load. This behavior is also called *creep*. Figure 9, adapted from Jansen (1989)<sup>1</sup> shows typical values of this behavior for various levels of stress for tensile test specimens. In the figure, the term *strain* is the change in length divided by the original length. Note that each division on the horizontal time axis is a change in magnitude by a factor of 10.<sup>2</sup>

**Figure 9. Strain versus time at various levels of sustained stress** (adapted from Janson).

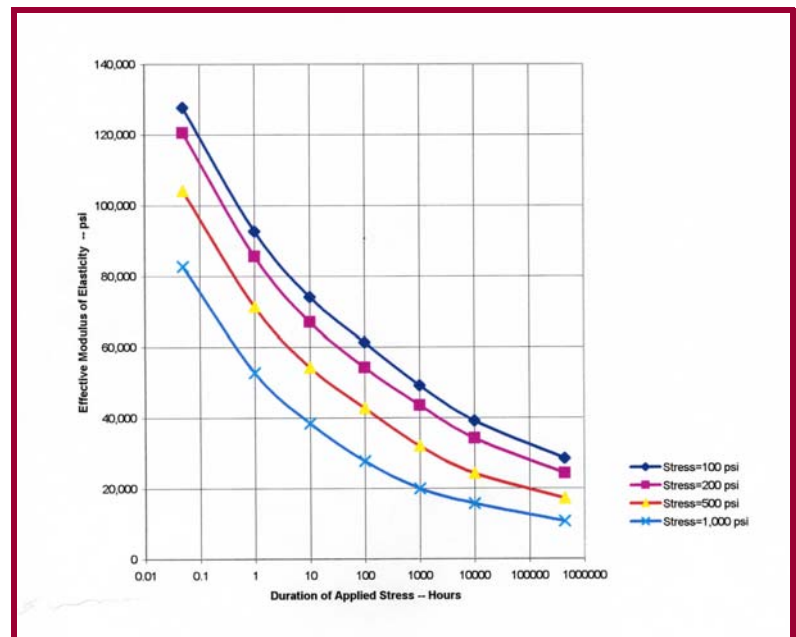
counts for the creep, which is called here the *effective modulus of elasticity*. Due to increasing deformations under sustained load, the effective modulus of elasticity of HDPE is reduced dramatically with time. Typical values of the effective modulus of elasticity are plotted versus time in Figure 10, as adapted from Janson (1989).<sup>1</sup> This figure demonstrates that the decrease in effective stiffness of the HDPE under sustained load, due to creep, is dramatic.

The stress in the main chamber legs due to the weight of the long term superimposed load (i.e. the paving and compacted gravel), as shown on Figure 3, varied from 270 psi to 420 psi. As shown on Figure 10, the effective Modulus of Elasticity for an axial loaded member with a sustained stress midway between 200 and 500 psi at one hour is 80,000 psi, but after 1000 hours (42 days) the effective Modulus of Elasticity will drop to 38,000 psi, and after 100,000 hours (11 years) it will drop to 24,000 psi. These values may be low for the subject HDPE, but the trends will be similar for a higher strength HDPE; i.e. the original Modulus of Elasticity will be reduced to approximately 50% after 1000 hours and 30% after 100,000 hours.

**Figure 10. Effective modulus of elasticity versus time for HDPE at various levels of sustained stress** (adapted from Janson).

38 and 48 inches. The estimated modulus of elasticity at 1 hour of sustained load is 110,000 (AASHTO, 1991).<sup>4</sup> Calculations based on this modulus indicate that the legs of the main chamber unit would not buckle. When the legs of the main chamber units collapsed, the compacted gravel backfill had been in place approximately 1½ months or 1100 hours. As the trends of Figure 10 show, the effective modulus of elasticity would be reduced by approximately 50% in that time, and calculations indicate that the legs of the main chamber unit would buckle under this reduced modulus.

The cause of the collapse was that the manufacturer did not understand the creep characteristic of the viscoelastic HDPE material used
